H-25 HELICOPTER

DROP TEST

22 October 1960

TREC Technical Report 60-75 AvCIR 1-TR-124

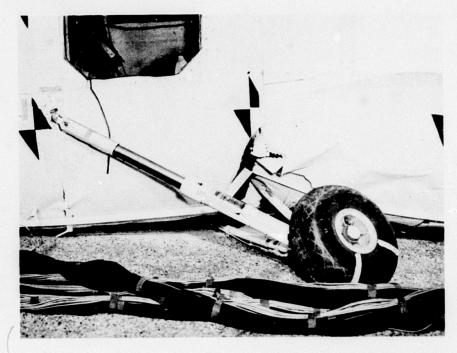
Figure 34. Post-Crash View of Right Main Landing Gear

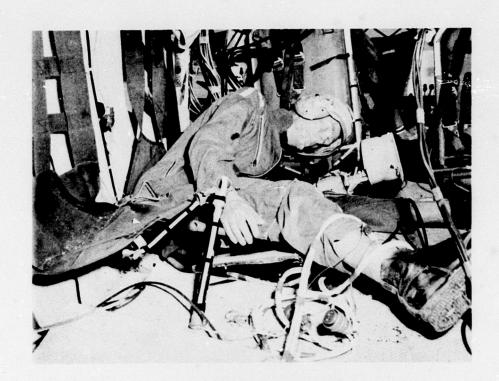
Figure 36. Post-Crash View of Dummy Passenger.

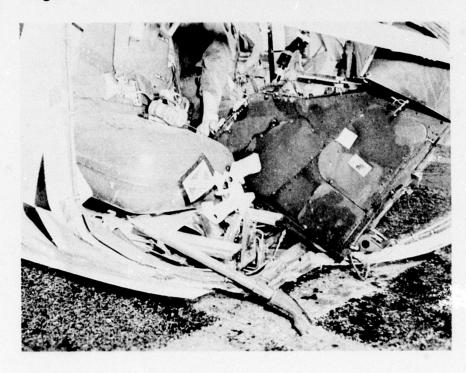
Figure 37. Post-Crash Damage to Range Extender Fuel Tank
